DYNAMIC SCIENCE, INC.
In-Depth Accident Investigation

Case Number DSI-96-AB-003

DYNAMIC SCIENCE, INC.
AIRBAG FIRE INVESTIGATION
CASE NUMBER: DSI-96-AB-003

Case Selection: As the result of an alleged interior electrical wiring fire, the driver's side airbag in a 1994 Dodge pick up truck self deployed. During this deployment the airbag inflator separated from the steering wheel and was projected through the rear wall of the truck cab.

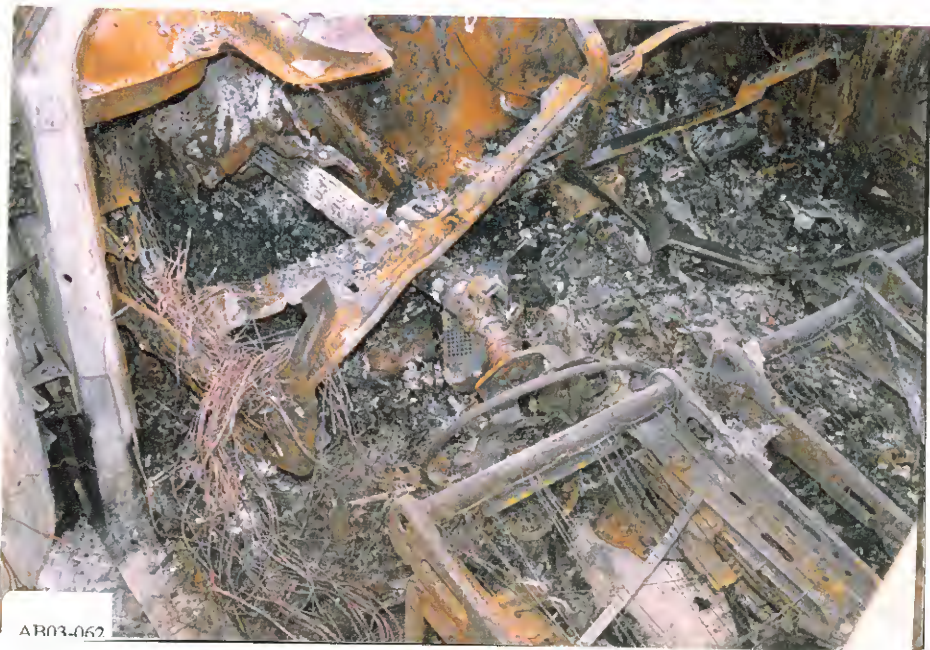
AB03-062

6. The steering column/steering wheel were found lying on the left front floor after the fire was extinguished. Found immediately rearward of the steering wheel/steering wheel hub, just forward of the left front seat, were the inflator's chamber cover, deformed initiator retainer, slag filter, airbag attachment ring and module attachment device (Photos 62 and 63).
